A Report of A Survey of Traffic Vibrations and Their Probable Effects on the Crocker Art Gallery

October 1959

State of California
Department of Public Works
Division of Highways
Materials and Research Department

59-06

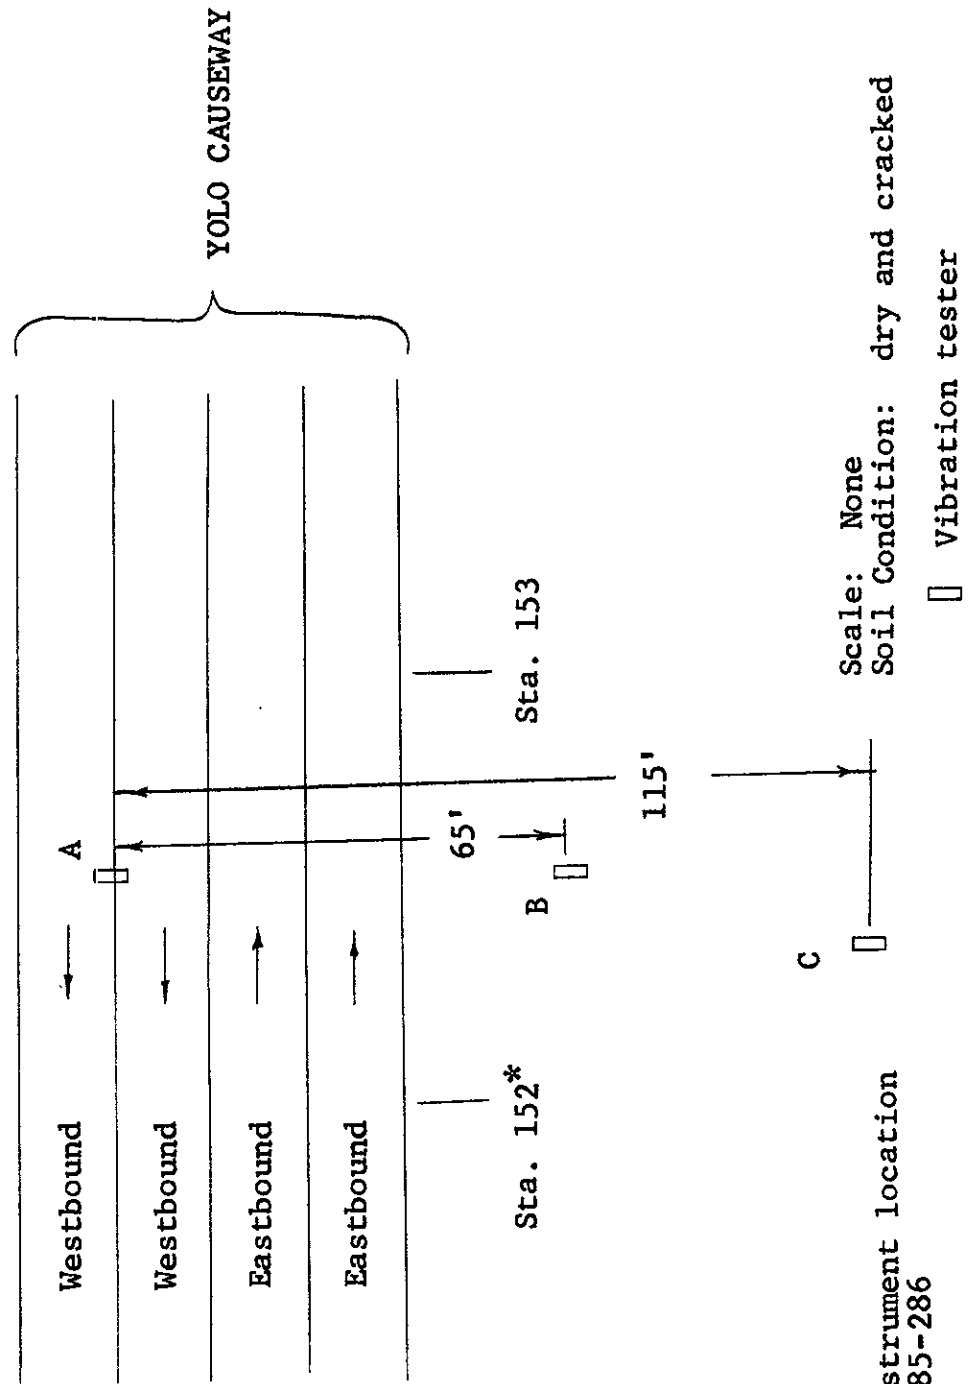
VIBRATION MEASUREMENTS - YOLO CAUSEWAY

INSTRUMENT LOCATIONS A, B, & C

* Identical instrument location
at Station 285-286

Westbound lanes are supported on
concrete piles, eastbound lanes
on wood piles.

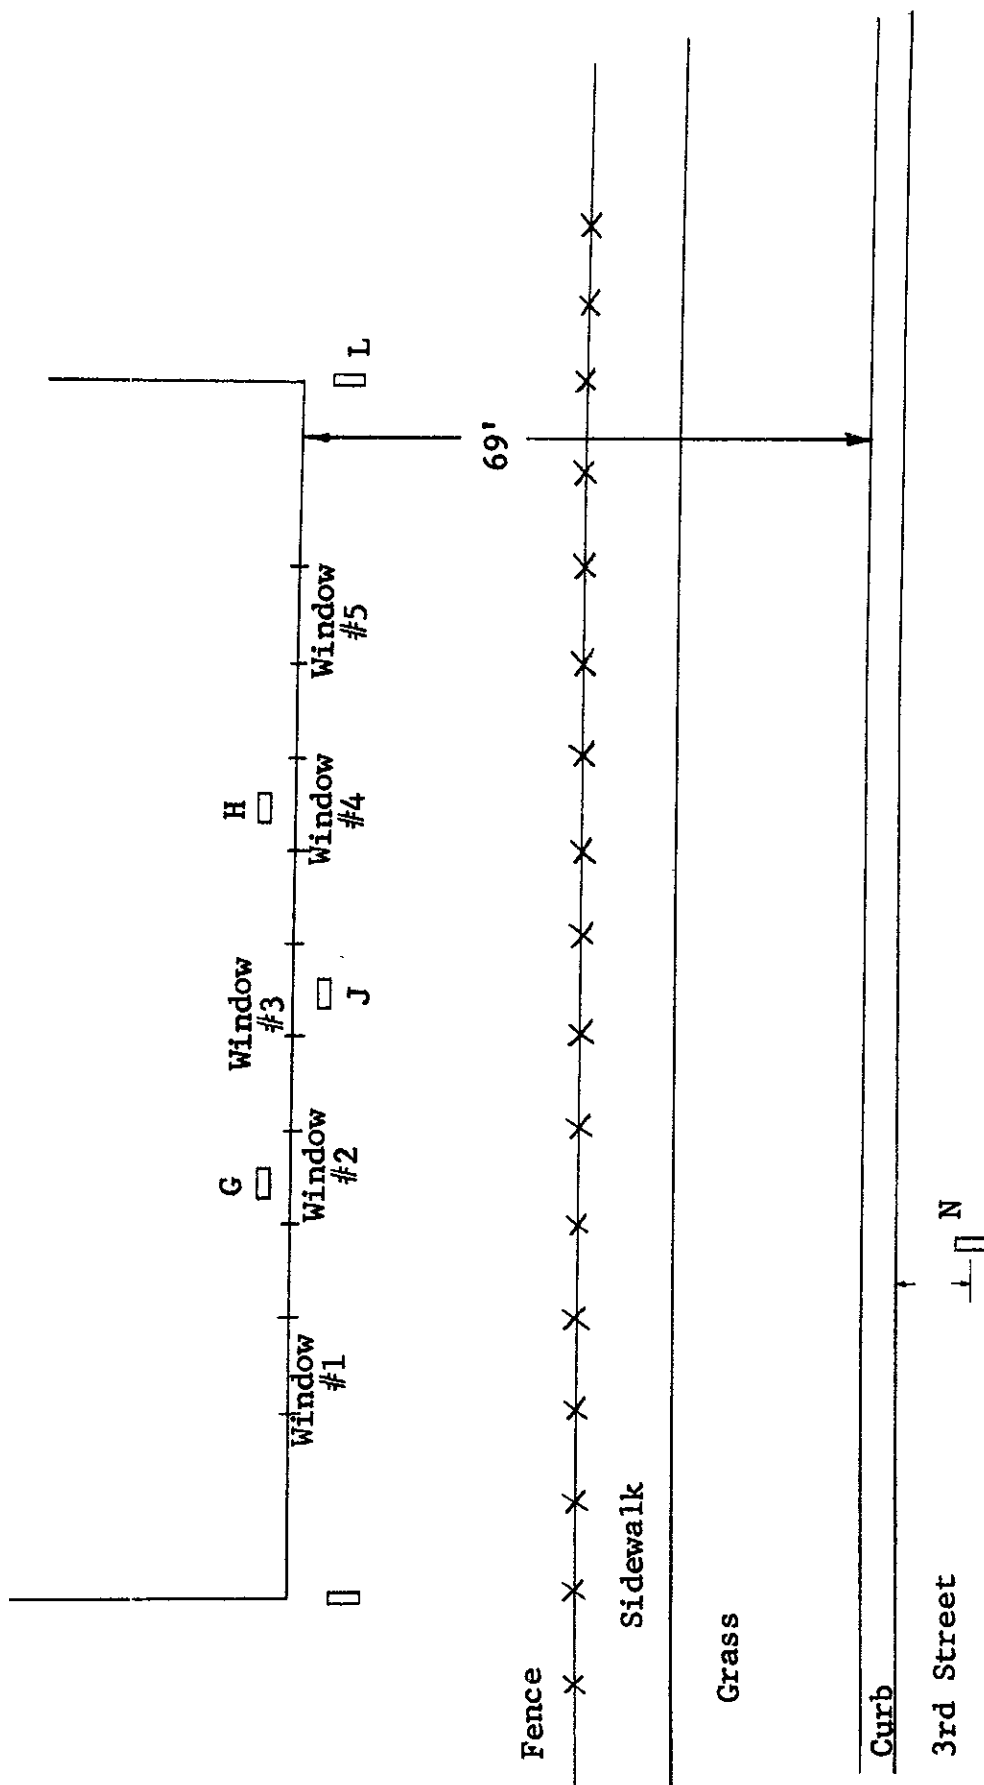
MAP III
VIBRATION MEASUREMENTS
CROCKER ART GALLERY - GALLERY ANNEX

Scale - none
Soil condition - damp
